Bamburgh Castle Beach Wreck

Technical report

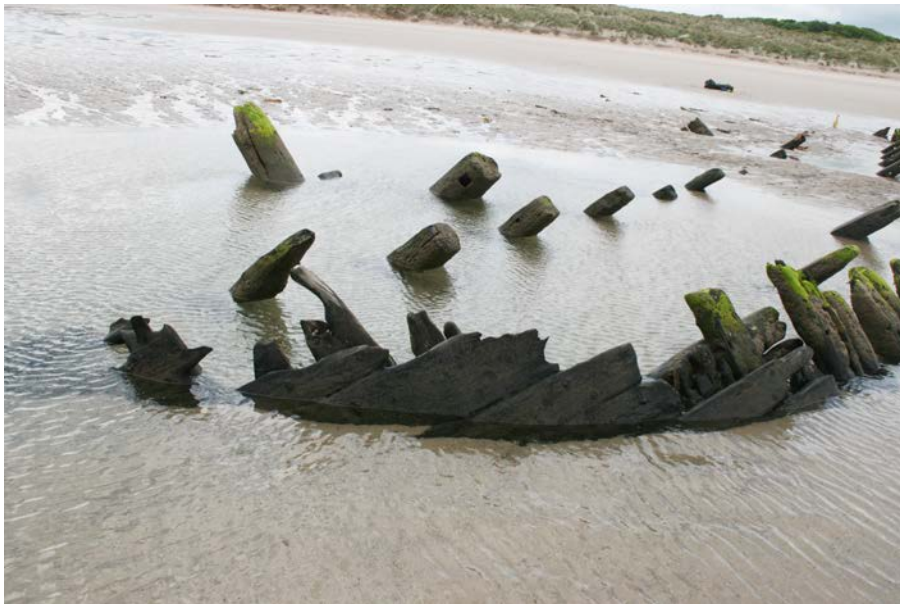
Figure 1. Outer hull planking 11.5cm thick 16cm wide and length unknown

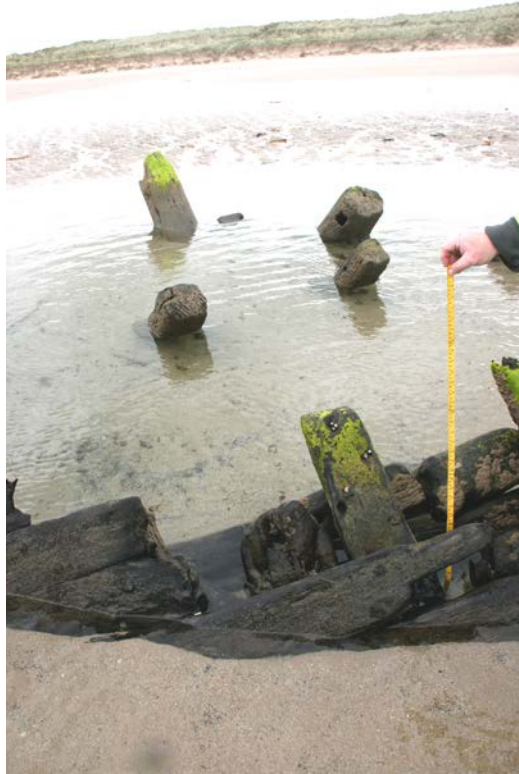
Figure 2. Ceiling planking 4cm thick 24cm wide and length unknown.

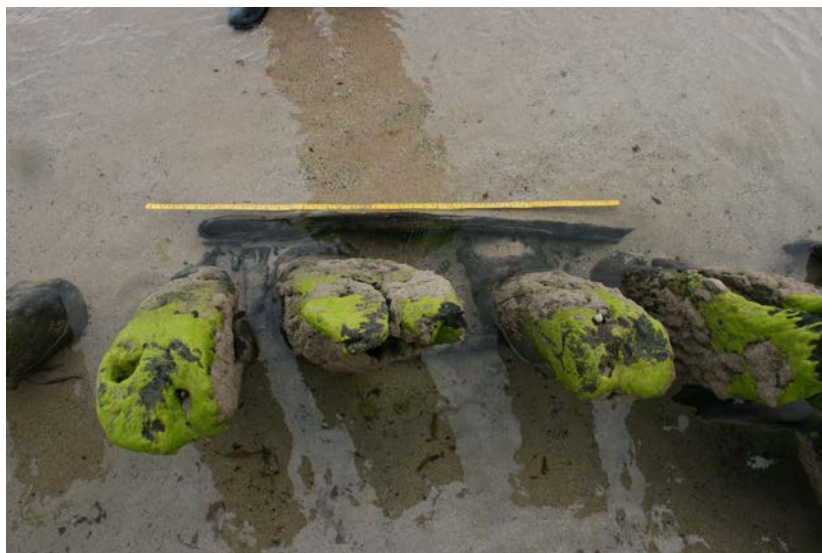
Figure 3. Frames (first futtock) 16cm moulded 11.5cm sided and length unknown.

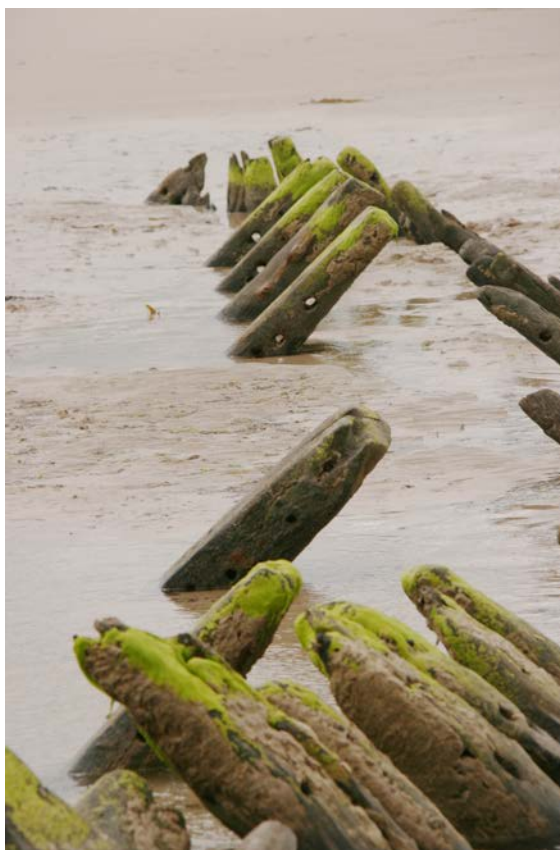
A total of seven lower deck beams are exposed. Their dimensions and features are recorded in order from bow to stern, (note number 4 was a cylindrical timber). The fastenings of this section appear to be using a mixture of wooden treenails and iron fastenings of some kind (possibly square nails). The one strange feature is that of the longitudinally aligned circular holes running through the lower deck beams (see image below).

Figure 4. Image showing longitudinally aligned circular holes running through the lower deck beams

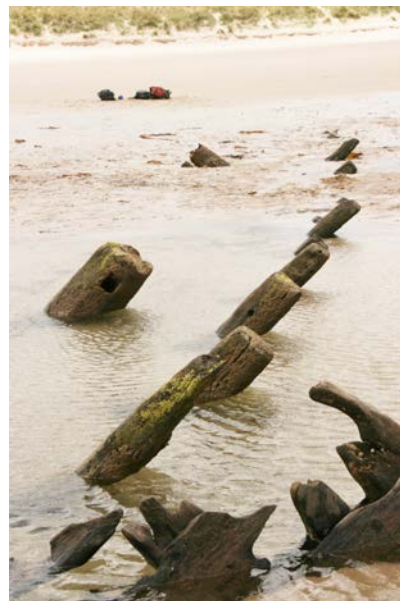
The stern section contains a further four main deck beam timbers. The most exposed of these being 30cm above the sand. All of the exposed faces of the timber are heavily eroded making any dimensions measured an estimate. (See image below)

Figure 6. All of the exposed faces of the timber are heavily eroded making any dimensions measured an estimate.

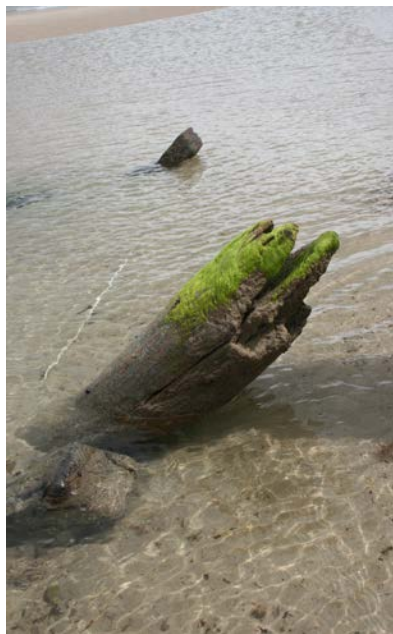
The mast in the bow lies approximately 4m aft from what could be the remains of the stem. It is cylindrical and has a circumference of 1.2m. Adjacent to the stern face of the forward mast a small squared off timber survives which is possibly a bollard used to tie off rigging ropes to. (See image below).

Figure 7. A small squared off timber survives which is possibly a bollard used to tie off rigging ropes

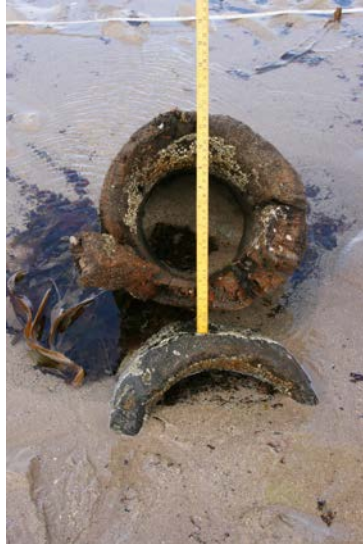
The cylindrical object in the stern lies approximately 16m aft of the possible stem. It has a circumference of 0.9m and has a hollowed core; this could be a product of erosion or more likely this may suggest that it is not another mast but could be something like a pump tube. It is not possible to ascertain this without further investigation. (See image below).

Figure 8. Possible pump tube or mast in the stern

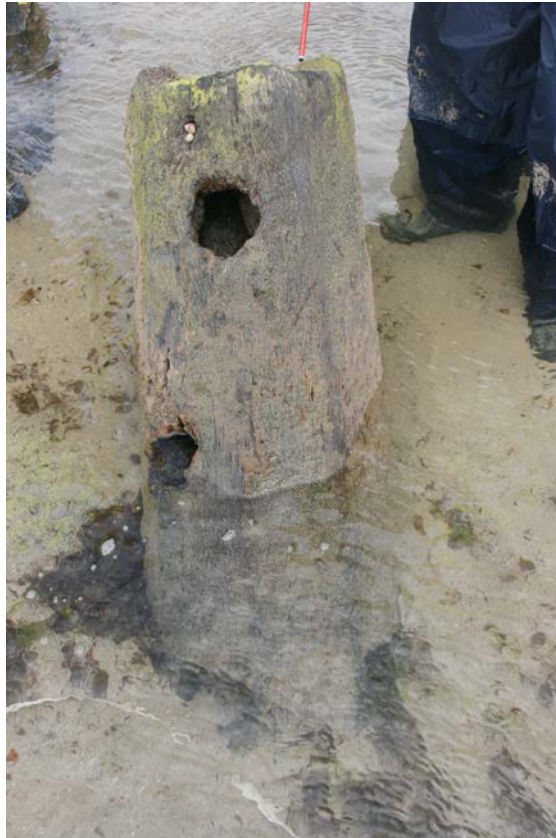
Within the exposed bow section of the wreck an exposed timber running from port to starboard above the main deck beams survives. The timber lies just aft of the exposed forward mast. The timber is cut with an octagonal cross section with square notches carved into the flattened faces. The diameter of the timber is 31cm and the exposed length is 1.1m. The square notches are between 10cm and 12cm square and penetrate through the width of the timber. A total of 10 notches are exposed making five complete holes running through the timber. The location and design of the timber would suggest that this is the remains of the starboard side of the windlass with the centre and port side possibly still in situ but buried. (See image below).

Figure 9. Likely remains of a windlass
