Bamburgh Castle Beach Wreck

Archaeological Survey

Archaeological Survey
Bamburgh Castle Beach Wreck

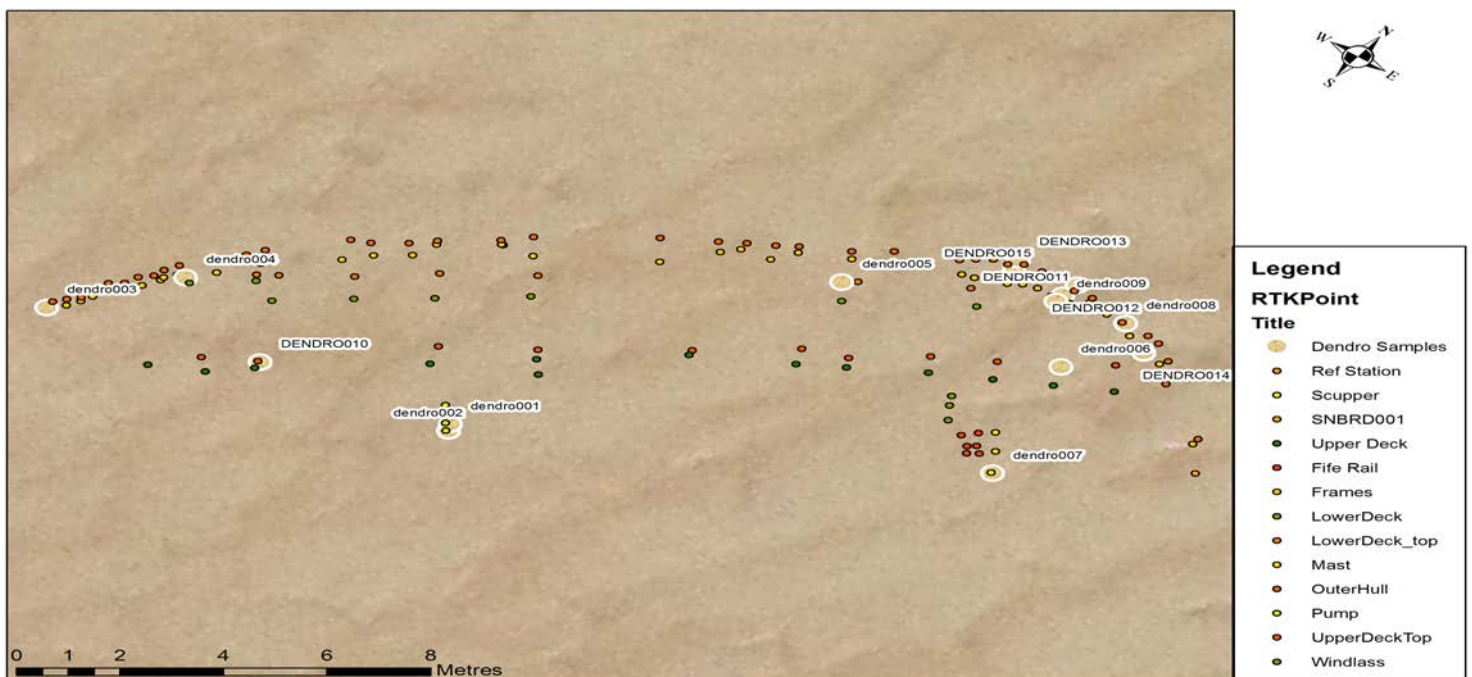
Image 1: Dendrochronology sample locations

Six samples contained sufficient rings to warrant analysis. Unfortunately none of the samples matched against each other. Five samples showed no match against British, European and North American oak tree ring chronologies. One of the samples proved to cross date against a variety of reference chronologies (figure 3), with a date range of AD1677-1758. As no sapwood survives on this sample only a *terminus post quem* of AD1768 (counting for at least ten sapwood rings after the last known heartwood ring AD1758) can be inferred for the felling date of the parent tree. (See **Image 1** below for sample locations). (See attached report by Dr Bale.)

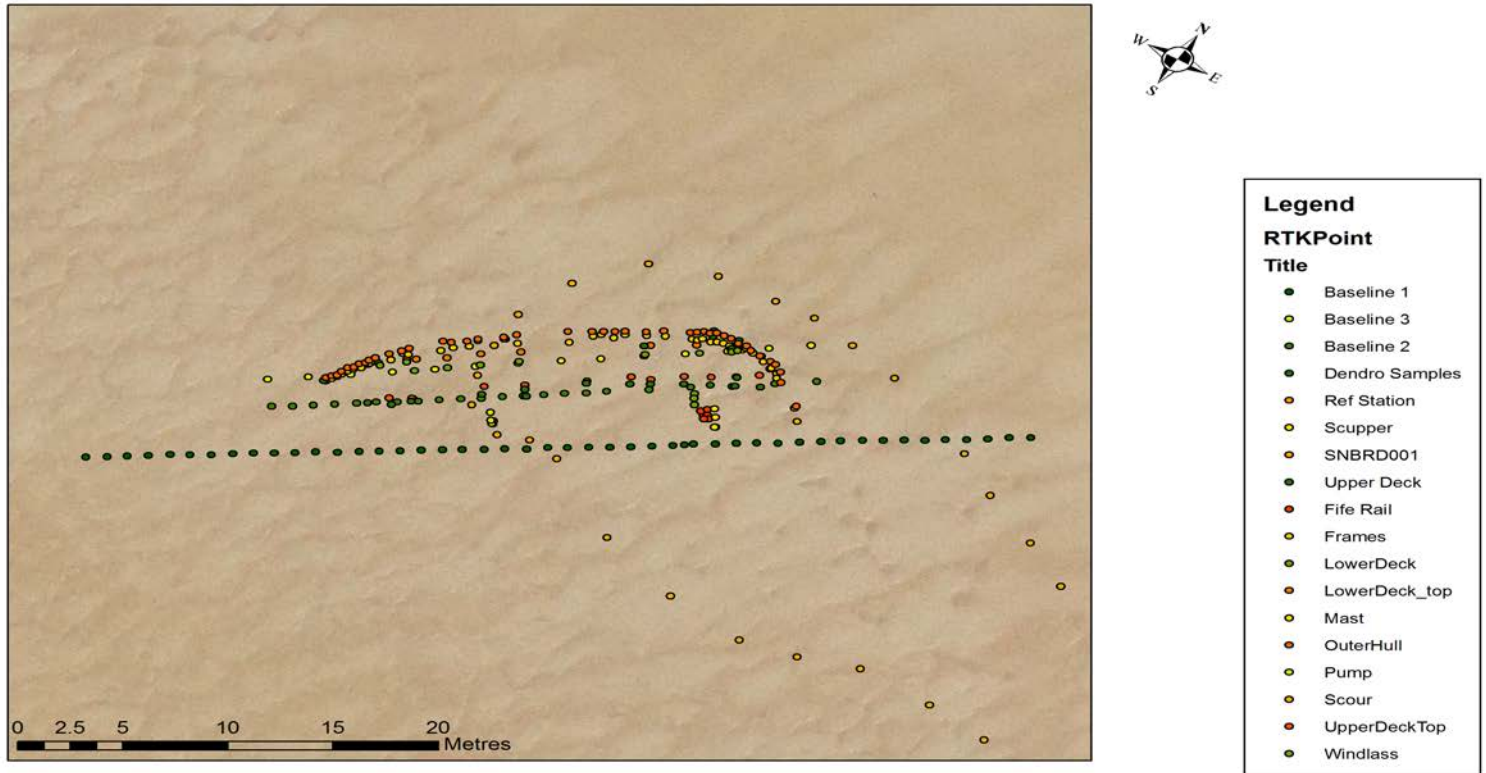
Image 2: Bamburgh wreck RTK survey locations

The general dimensions and description of the exposed features is covered in MAST's previous report (Berry & Stratford 2013). A continuation of the survey was completed using a Leica Viva GS10 GPS recording system to accurately position the wreck features and how they relate to each other

In order to establish the depth of any buried material an air probe survey was conducted using three baselines at different cross sections of the potentially buried starboard side of the wreck. The locations of these baselines can be seen in **Image 2**. (The air probe has a maximum depth of 1.86m)

The depth of the probes taken along the baseline indicates some possible buried material within the first metre of sand at 21 locations across the site. Due to the nature of the sediment it is likely that some of the material may be natural. The shallowest material as expected appears to be within the stern section (further inshore) and the amount of contacts reduced towards the bow of the wreck. The nature and extent of buried material could be further investigated by undertaking a targeted test pit from the GPS located probe depths.
